Effects of Vertical Deficiency Location on the Structural Behavior of Steel SHS Short Columns

A. Shabani Ammari, K. Narmashiri*

Department of Civil Engineering, Zahedan Branch, Islamic Azad University, Zahedan, Iran

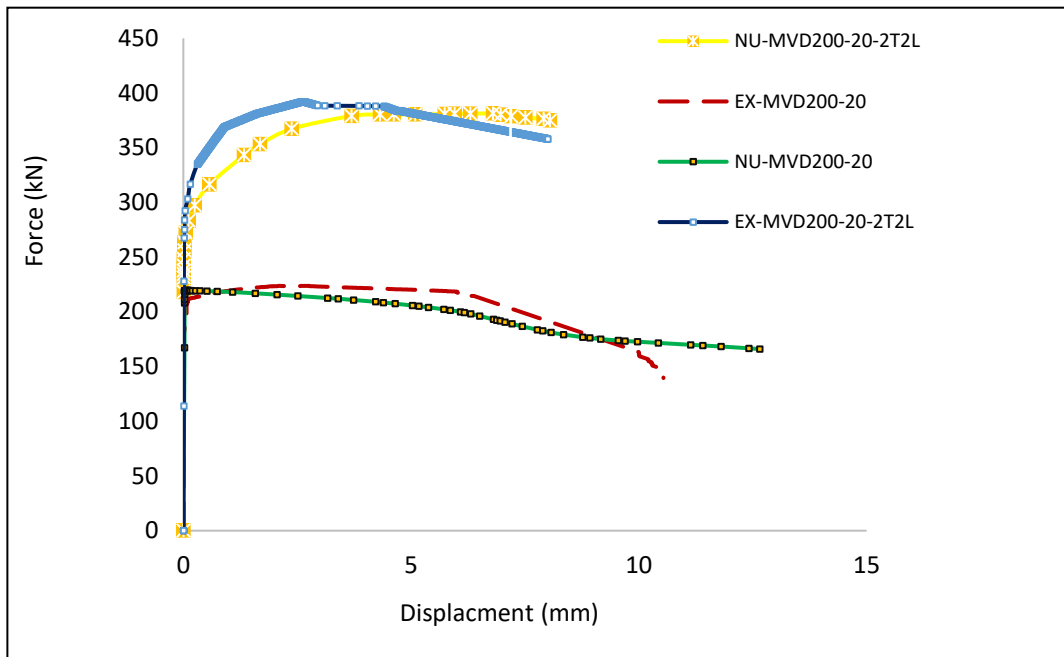
Fig. 5. Force-displacement diagram of the columns with vertical deficiency of middle element (a) top, (b) middle, and (c) bottom

MVTD200-20 is the deficiency at the top of the middle element. As it is shown in Fig.5a, the load-bearing capacity of the damaged column declined by 7.46% compared to the control sample after imposing vertical deficiency. Displacement increased by 9.23% compared to the control sample. Using four longitudinal and transverse CFRP layers coupled with enclosed deficiency area increased the bearing capacity of damaged columns by almost 390 KN, which is 63.48% compared to the control specimen (Fig.5b).

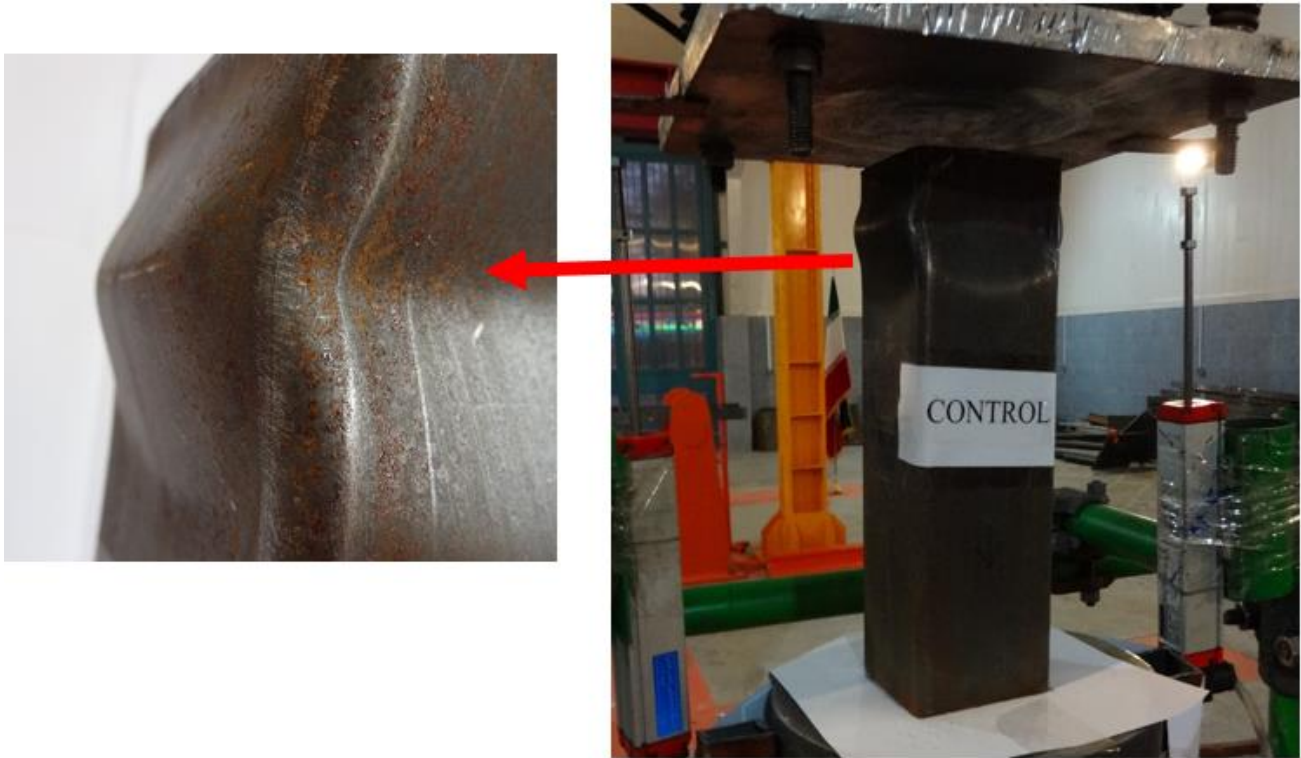
Fig. 7. Failure modes of Control specimen

factors to study the behavior and failure of damaged columns. Firstly, the behavior and rupture of the specimen with no deficiency are studied. Fig.7 shows the control column before and after failure. Elephant Foot Buckling was observed after completing the test, which is mainly associated with prevailing the force over internal elements in the elastic area of the element.

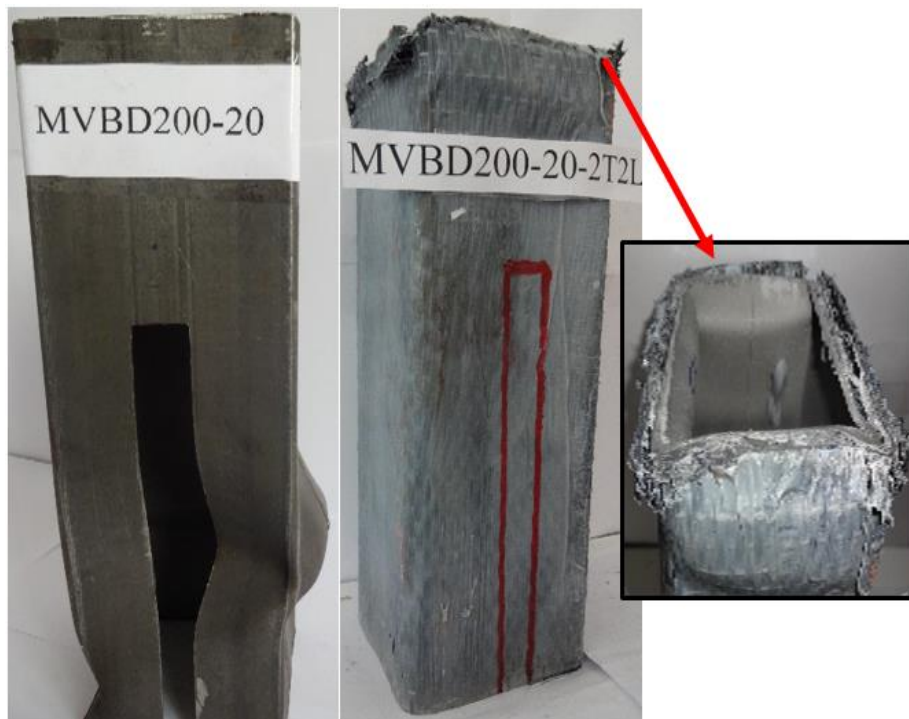
Fig. 10. Failure modes of the specimens with middle-bottom deficiency: non-strengthened and strengthened

Fig.10 shows the vertical deficiency at the bottom of the middle element. As it is clear, the deficiency caused local

buckling along with the deficiency and energy absorption limitation. Increasing local buckling along the vertical deficiency caused the maximum stress and strain distribution. This specimen experienced the most critical situation among the specimens with vertical deficiency. Using four longitudinal and transverse CFRP layers had a significant effect on the strengthening and stiffness of the damaged specimen. As Figure 10 showed, VFRP layers minimized the deformation by wrapping the location of deficiency. On the other hand, increasing vertical loading caused the rupture and CFRP separation exterior to the deficiency. CFRP separation at the top location of the element happened due to increasing local stress and strain distribution.

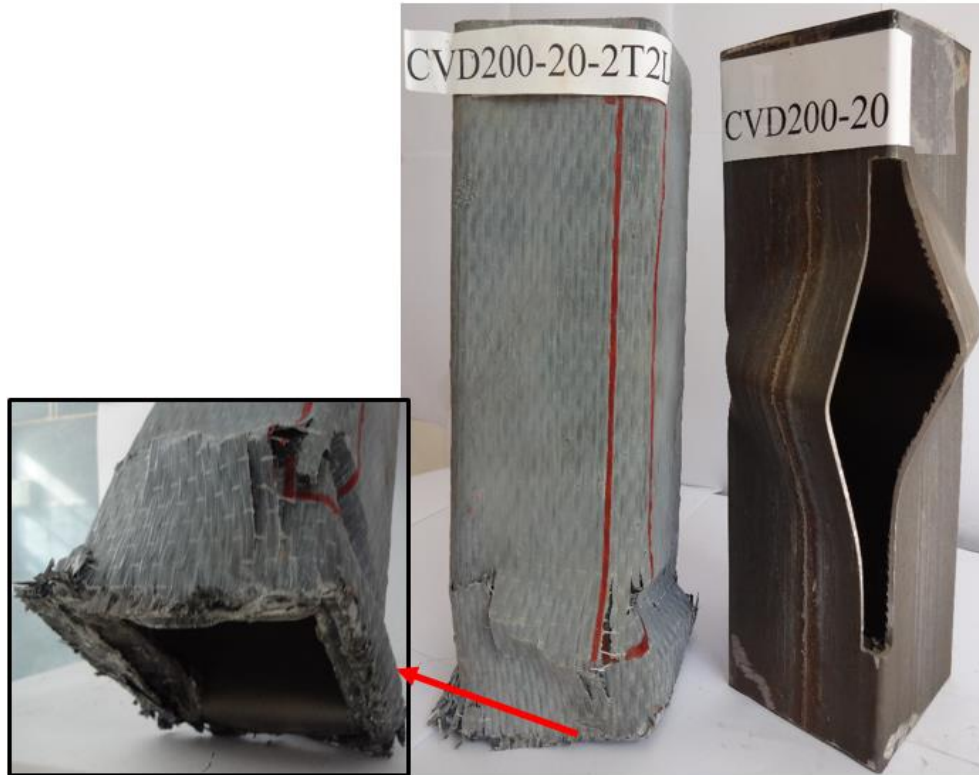
Fig. 11. Failure modes of the specimens with corner deficiency: non-strengthened and strengthened

We also studied the behavior of steel columns at the corner element. As it is clear in Fig.11, the vertical deficiency in the middle of the corner element caused the deficiency opening, increased axial deformation, and local buckling at the exterior of the column. This specimen experienced maximum bearing capacity, displacement, and axial deformation. This is the most critical specimen among all specimens. The experimental results of strengthening showed that carbon fiber had a significant effect on increasing ductility, absorbing energy, and reducing the stress distribution of steel columns. Failure and separation of carbon fiber at the end of vertical deficiency are due to increased bearing capacity, energy absorption capability, and local buckling at the foot of the steel column.
